OOK at Adrian Hall's Wolseley Hornet at a show, and you'll probably think it's another pampered concours competitor on one of its rare sunny summer outings.

Adrian, 19, from Sussex, bought the Wolseley in 1989, intending to restore it to a 'good condition two' standard, ready

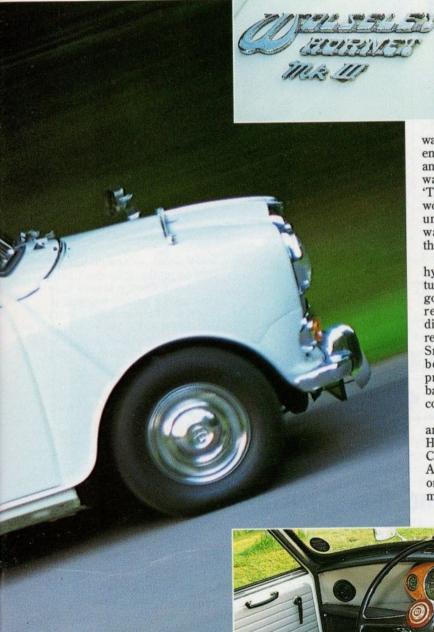
Condition of interior

with, but now it looks as though it is just out of the showroom

was good to start

The interior had remained in good condition, merely requiring a new carpet set, and the handbrake lever repainting!

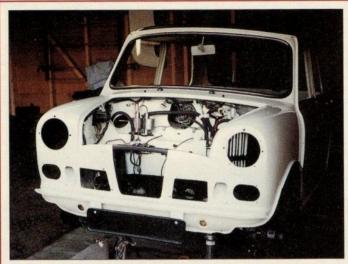
Finished shell, with wiring and hydraulics back in place
