Wolseley awakes

A cosmetic tidy-up of Mick Clarke's Wolseley didn't quite go the way he planned. The result is a concours car, as Nick Larkin discovers

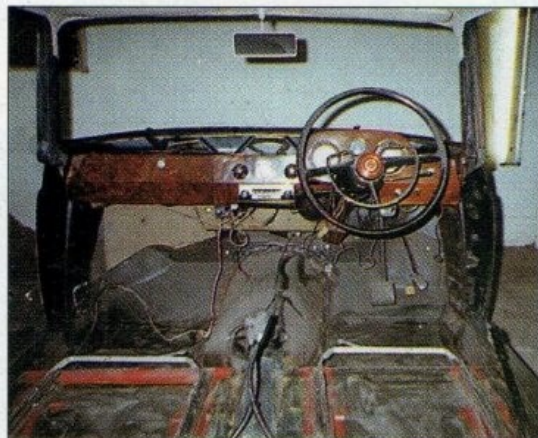
The Wolseley's interior was stripped out before rusty bodywork was removed with a chisel

The old wings were removed with an air chisel, and the new ones fitted – after quite a lot of trial and error – using a MIG welder. 'I'd done some gas welding in the past but had never tried a MIG. Practice was definitely needed.'

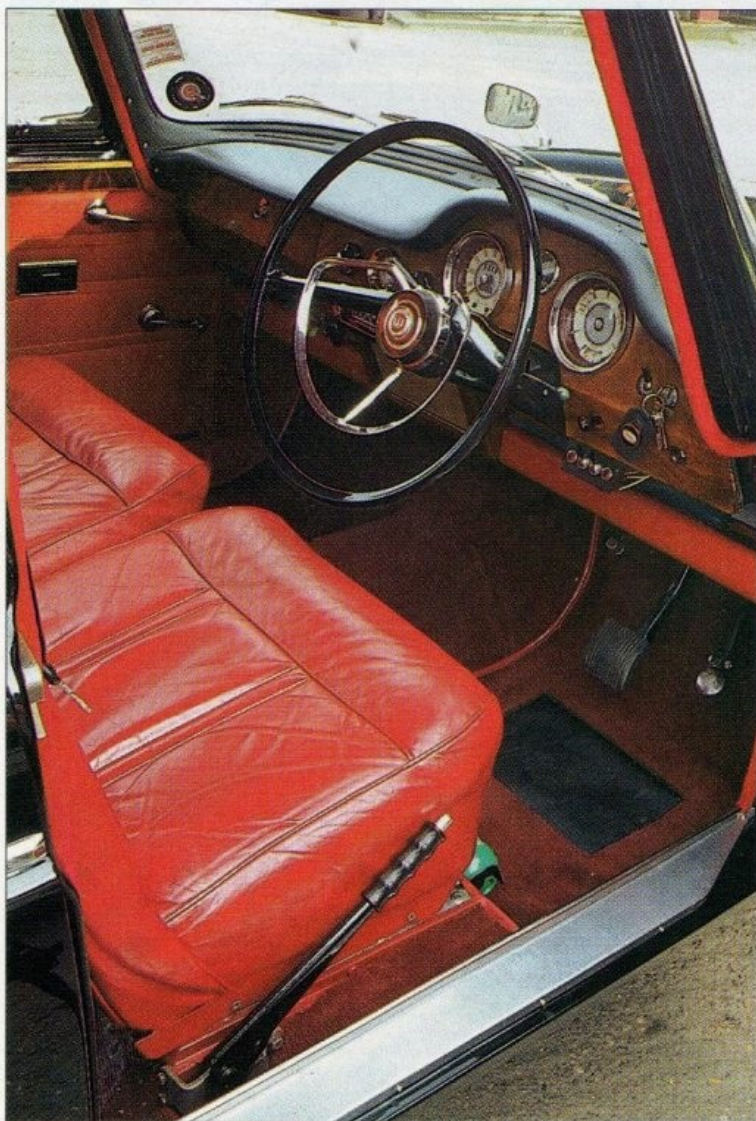
Above, leather seats were restored with a kit from Woolies
Right, illuminated Wolseley badge adorns traditional grille

Meanwhile, Mick was busy restoring the car's seats, with the aid of a leather renovation

kit from specialist Woolies, which he highly recommends. This firm also supplied new Furflex-style edging for the door surrounds.

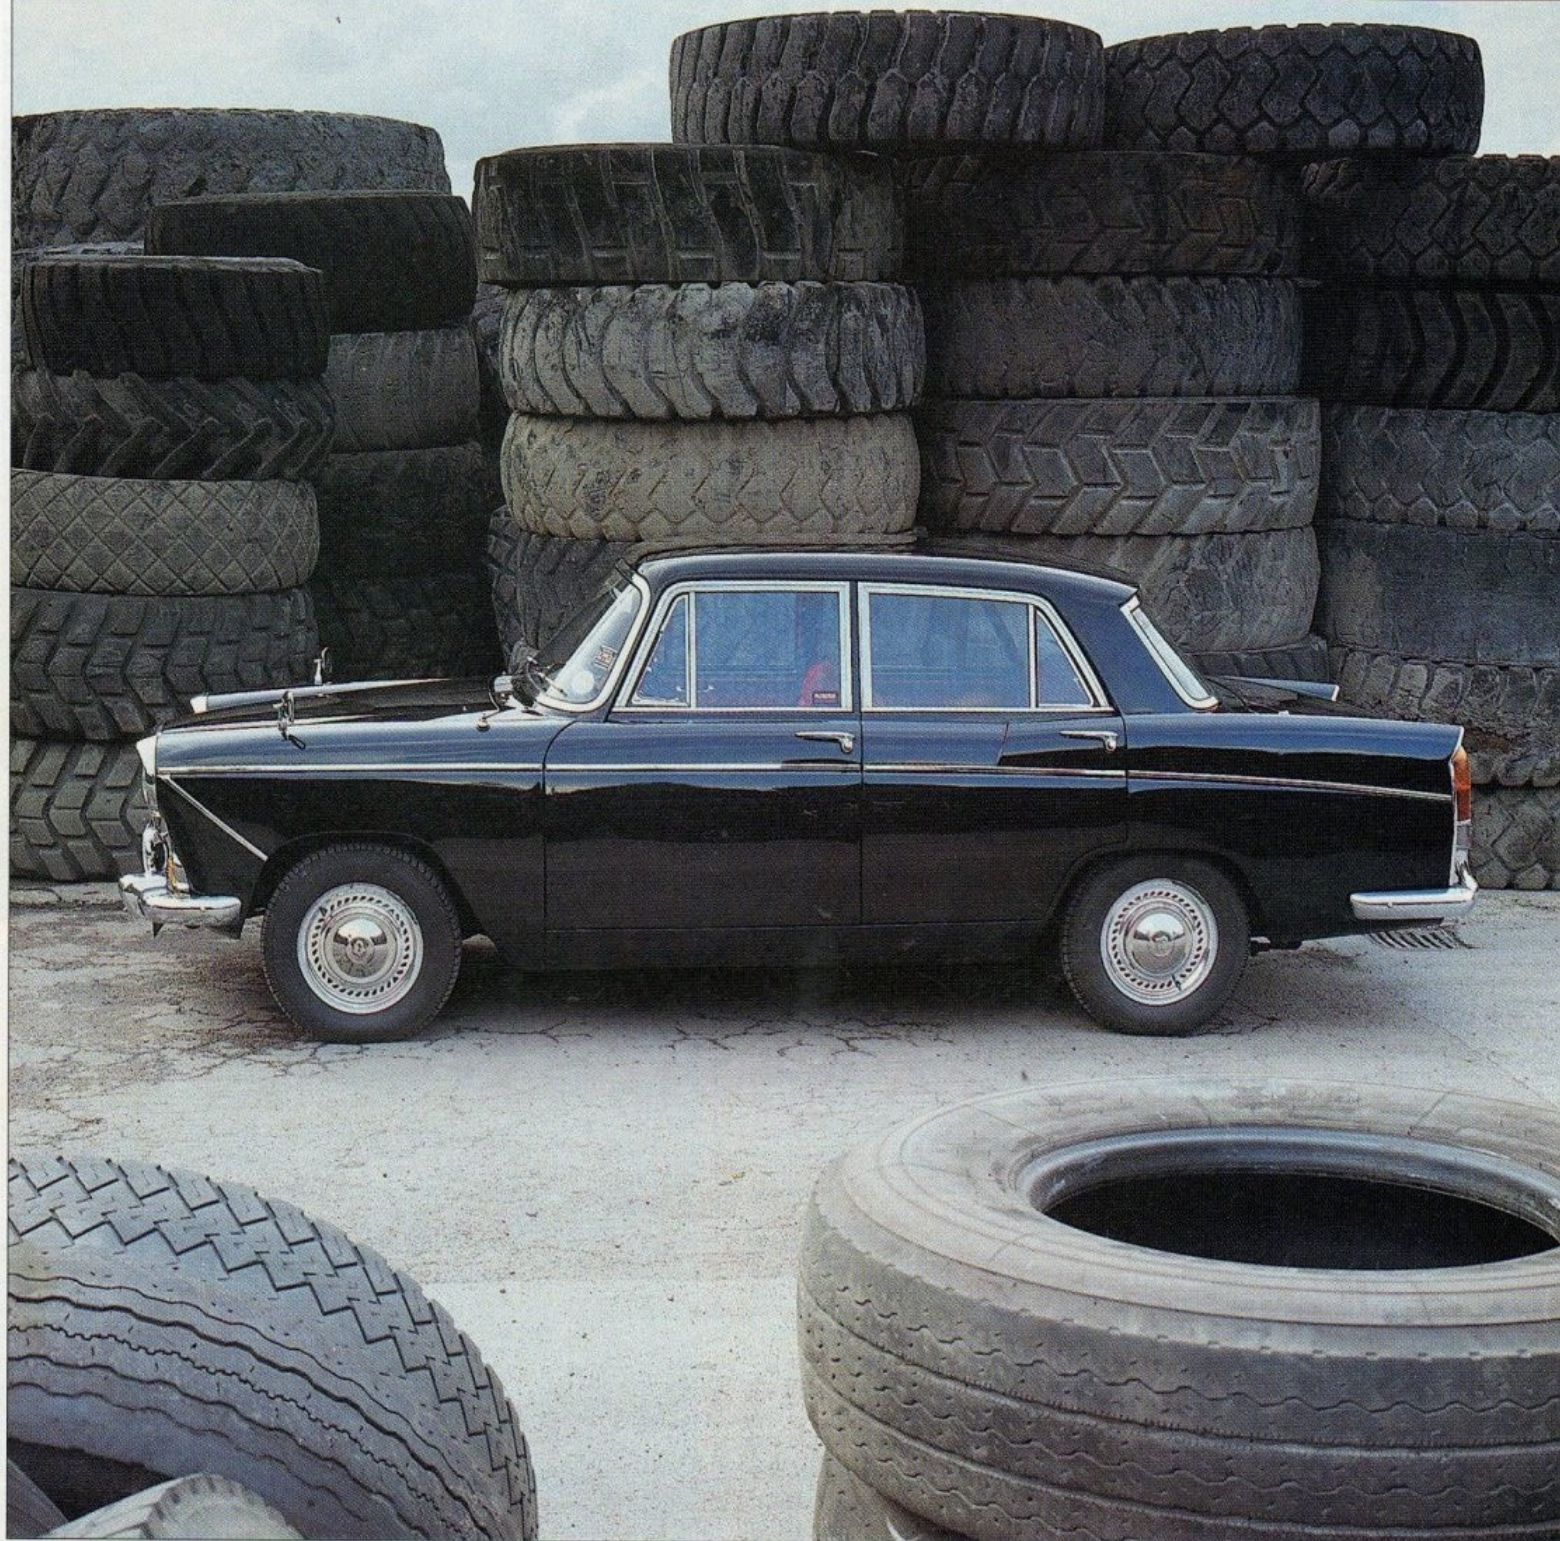
Above, the car was finished in two-pack paint for durability, with black Hammerite on the underside

Mick had arranged for this task to be carried out at the garage where he works. The bodysell was stripped down to bare metal with a circular sander and etch primer applied, followed by half a dozen undercoats and three top coats of two-pack.

'I decided on two-pack as it's easier to look after and more durable,' said Mick. After the old underseal was removed, Mick treated the entire underneath to a couple of coats of black Hammerite.

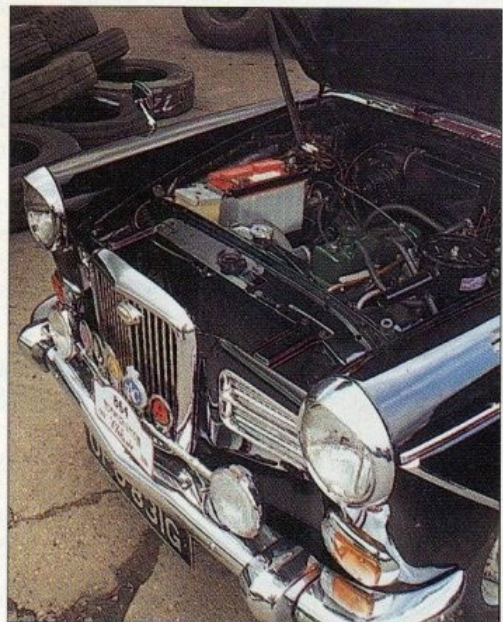
Right, engine is the 1622cc B-series fitted to Farinas from 1961. This car has the optional automatic 'box

The engine ran well, though with 60,000-odd miles on the clock was ready for a decoke.

A couple of valve seats and a rocker shaft were also needed. A thorough inspection of the 16/60's wiring revealed everything to be in generally excellent condition, with only a couple of new connectors required.

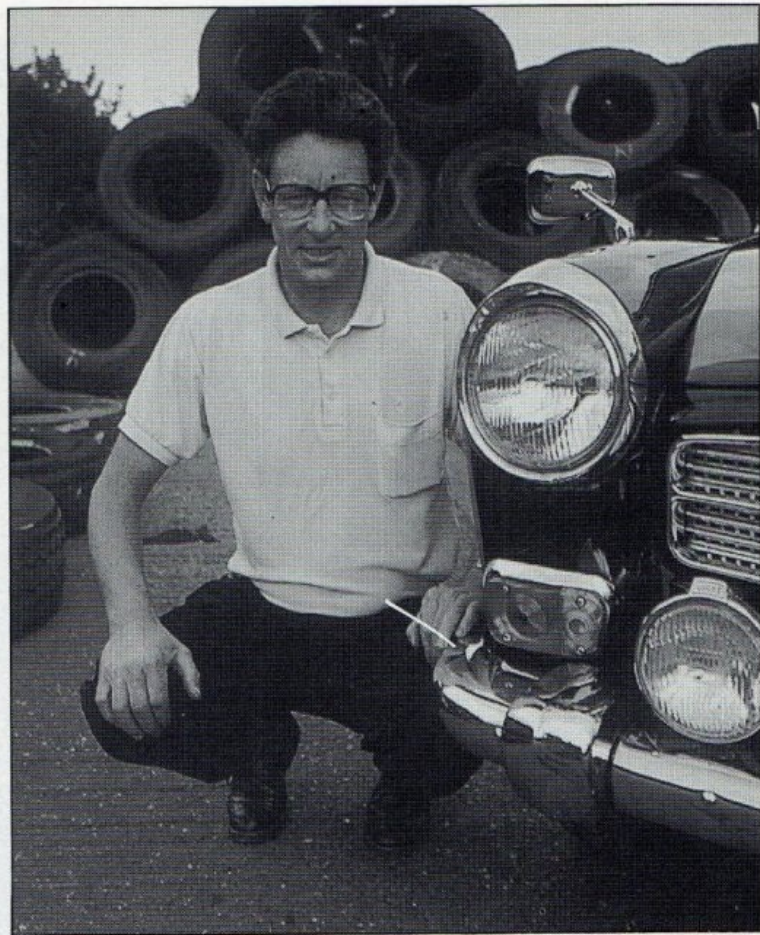
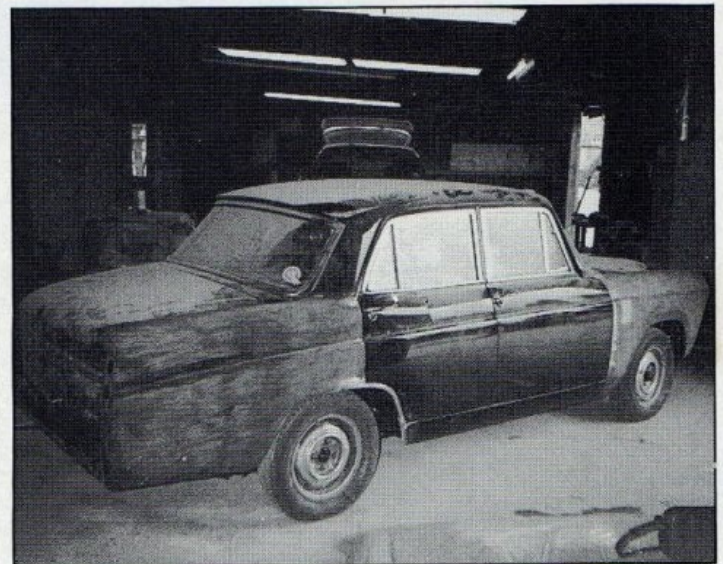
New wings were fitted front and rear – a lucky find

By a miracle, Mick heard at a club meet about a man in Manchester with four new Wolseley wings for sale. Such tales abound in Farina circles, and are often tall stories in the way that anglers claim to have captured 50ft long trout. But this particular tale was nearly true – the rear wings had never been on a car, but the front ones, although virtually rot-free, had been painted in a foul, thick brown paint.

'Looking back, I went mad, but it seems to have worked. There's no sign of rust bubbles,' Mick reckons that fitting the rear wings was by far the worst part of the restoration. 'They have to be lined up with the boot floor, the wheelarch and the D-post, which takes ages.'
